Technical Journal

Oil consumption, "Low oil Level" or "Oil level low" in DIM

REF NO: TJ 24643	ISSUING DEPARTMENT: Technical Service	CAR MARKET: United States and Canada		
PARTNER: 3 US 7510 Volvo Cars North America		ISSUE DATE:		
FUNC GROUP: 2100	FUNC DESC: Engine	YEAR 2013	MONTH 05	DAY 15
Page 1 of 77

Volvo Car Customer Service	
	TJ Instruction
	TJ No 24643
	Date May-13 Issue 07
Title	Excessive oil consumption, Low oil Level message in DIM

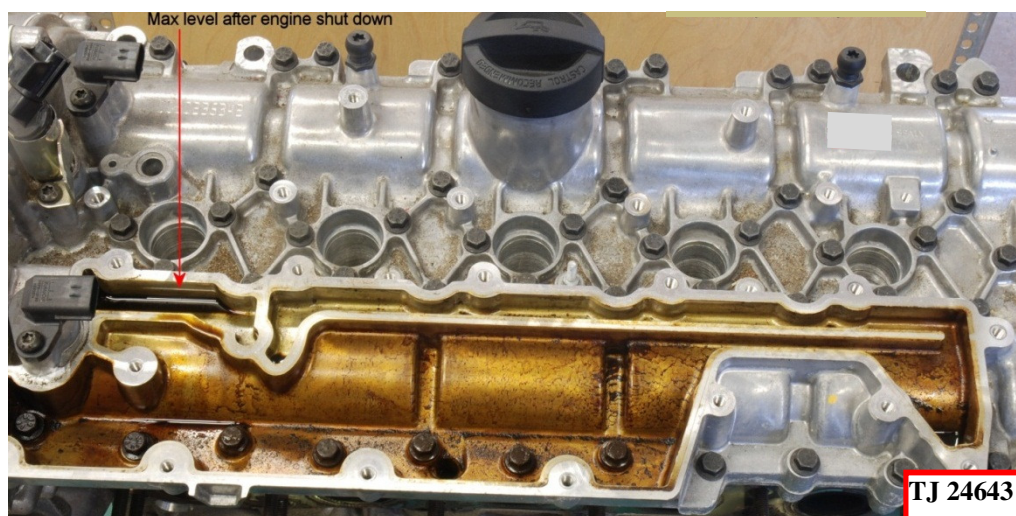
Oil in the small breather channel can be the result of multiple issues such as the engine being overfilled with oil, a defective breather box, excessive crankcase pressure or other. Oil in the small breather channel will be vented into the cylinders causing carbon/ash build-up in the cylinders starting with cylinder #6.

Photo 3. Oil in the breather channel indicating a possible PCV box (oil trap) failure

MY2011-2014 with Engine code 90: If the spark plug from cylinder #6 has more soot/ash than the others and the oil galley looks like that shown in Photo 3, then the oil trap is most likely at fault. Replace the oil trap, but still review the results from Steps 5 - 7. If the results from steps 5 - 7 are OK, then only replace the oil trap.*

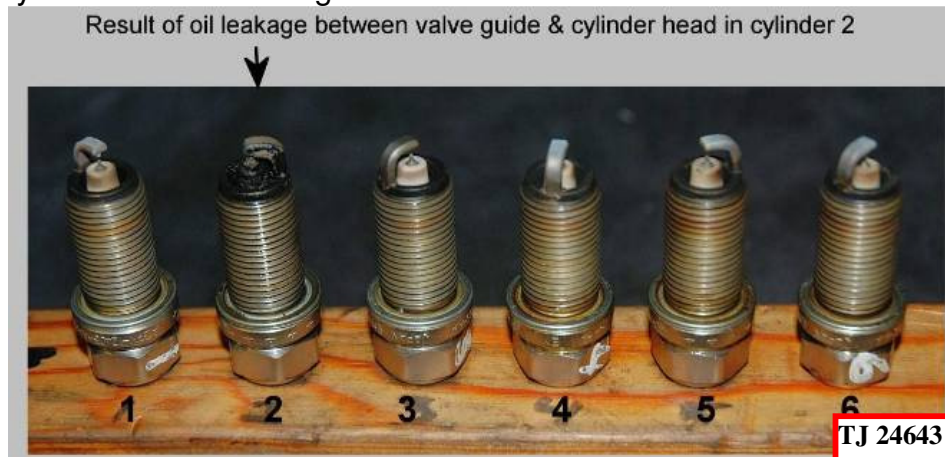
Look at the spark plugs in Photo 4 below. If the valve guide is leaking in a cylinder, the corresponding spark plug will have more soot/ash than the others. In the example in Photo 4, cylinder 2 is consuming oil.

Note that this test is only for the intake valve guides. If valve guide leakage is suspected and there is excessive white/blue smoke from the exhaust, then there is a possibility that the exhaust valve guide is leaking. In that case, the exhaust manifold should be removed and the exhaust port should be checked for excessive oil deposits. The head must be removed for the exhaust valve guide check if using the air pressure method. Only do this if it is clear that one spark plug has more soot/ash than the others as shown in Photo 4.

If leakage is found on the intake or exhaust valve guides, then replace the cylinder head and add to the repair any faults found in previous steps.

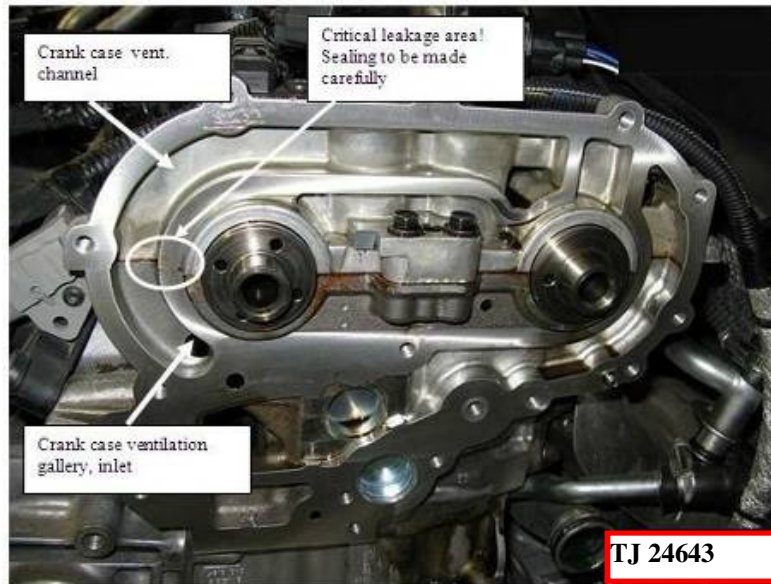
If spark plugs in cylinder 6 & 5 have more soot than the other plugs and the engine is built before engine production date 1504100001 (DDMMYYxxxxx), then remove the cam cover and inspect the sealing surface. Refer to Photos 7 and 8 below.

Photo 7. For reference only, not a valid check

If the sealing surface is discolored by oil as shown in the photos, it is most likely that there is a leak between the cam cover and the cylinder head. If this is the case, reseal the cam cover and add to the repair any faults found in previous steps. Be sure to check the expiration date of the sealant bottle before use.

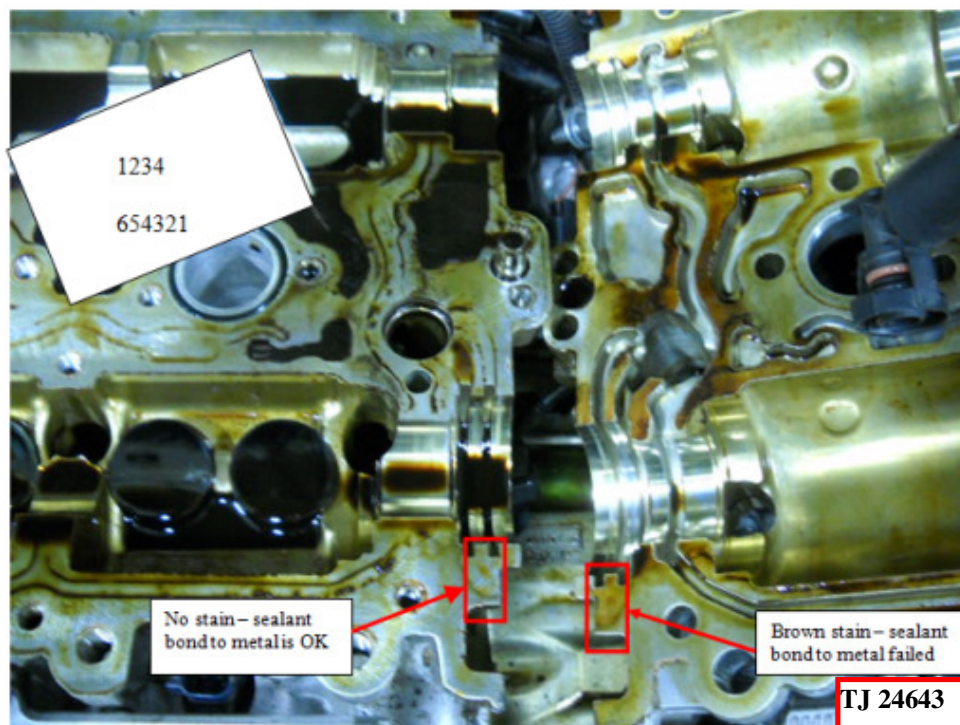
Photo 8. Check method for cam cover sealing surface. Note the placard with retailer number and chassis number is required upon submission of this photo to prior approval.

The cam cover seal was improved at engine production date 15041000001 (DDMMYYxxxxx). The production date, in this case is April 15, 2010. The engine serial number can be found using VIDA "Vehicle Details".
