Technical Journal

Oil consumption, "Low oil Level" or "Oil level low" in DIM

REF NO: TJ 24643	ISSUING DEPARTMENT: Technical Service	CAR MARKET: United States and Canada		
PARTNER: 3 US 7510 Volvo Cars North America		ISSUE DATE:		
FUNC GROUP: 2100	FUNC DESC: Engine	YEAR 2013	MONTH 05	DAY 15
Page 1 of 77

Volvo Car Customer Service	
	TJ Instruction
	TJ No 24643
	Date May-13 Issue 07
Title	Excessive oil consumption, Low oil Level message in DIM

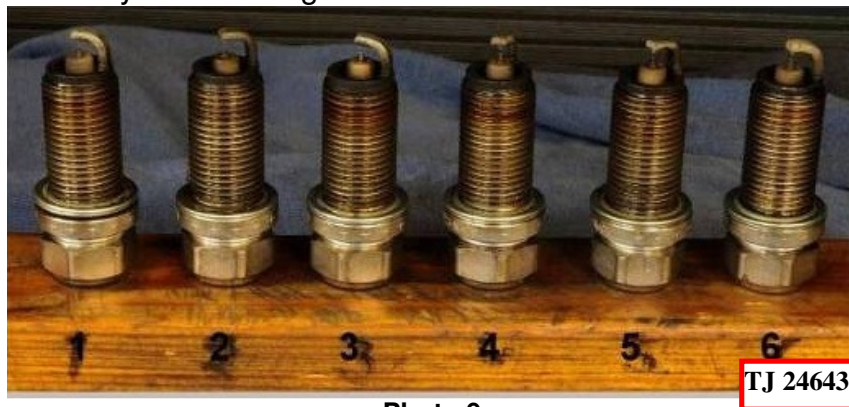
If the spark plugs are all equally dark (see Photo 9 below), then the oil control rings are at fault. See "Information on piston rings" below.

A new piston and oil control ring were introduced into production at engine date 301011B21530 (DDMMYYxxxxx). Follow the steps below for the service solution for engines built up to this date.

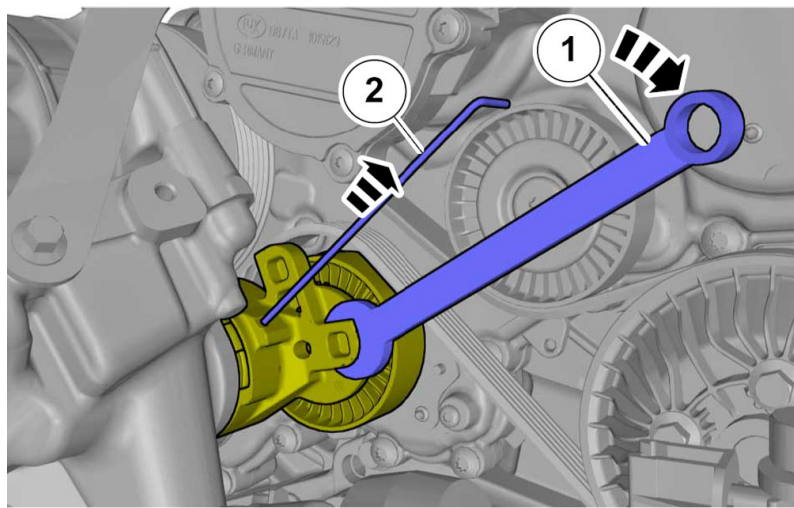
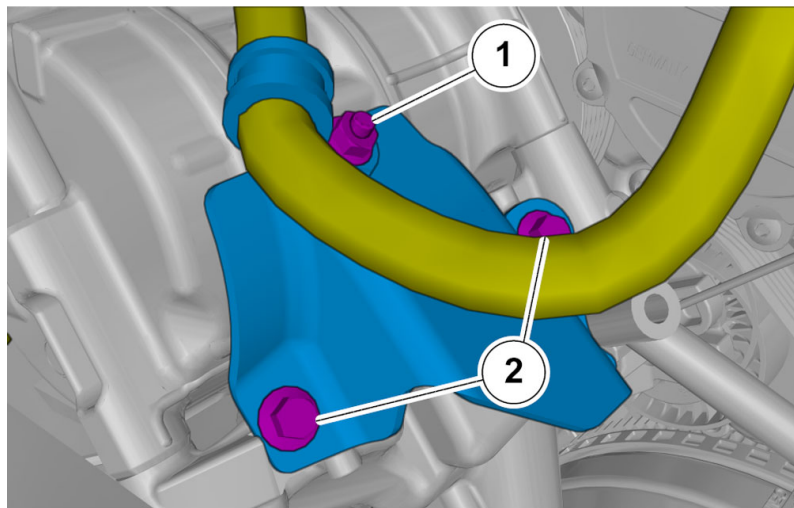
- 1. **Torque:**
M6, 10 Nm (88.5 lbf-in or 7.4 lbf-ft)
- 2. **Torque:**
M8, 24 Nm (17.7 lbf-ft)
